Umatilla NATIONAL FOREST

CORNERS OF THE PUBLIC SURVEY

T. 1 S R. 37 E W Mer.

Quarter Corner common to Sections
17, and 20

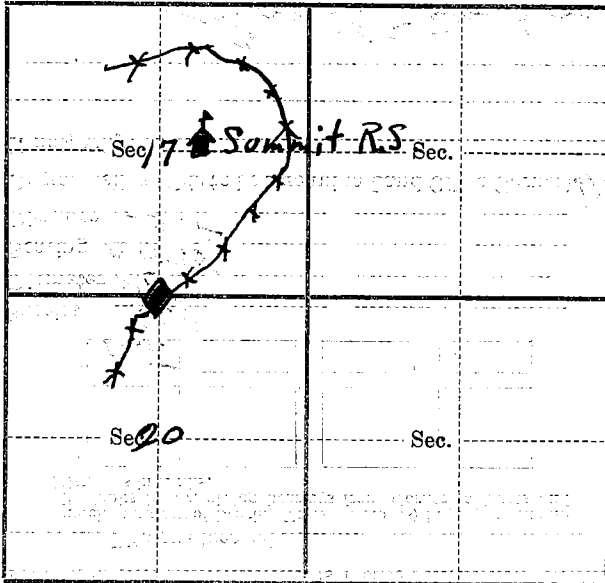
(Make sketch of topography near Corner)

Metal Location Poster is on a J.P.
tree 36 inches diameter, on the North
side of Corner
from which this Corner bears South 15° E
20 ft chains distant.

near Summit R.S. Along
South side of pasture
about half way down
hill. Witness tree is
on fence line and wire
is nailed thereon.
