OREGON CORNER RESTORATION FORM

Section 1 Township 2N Range 32E  
 County Umatilla Date: July 24th, 2020

Corner Designation: 2N32E23

Quarter Corner common to Sections 1, and 12, T2N,  
 R32E, W.M., Umatilla County, Oregon.

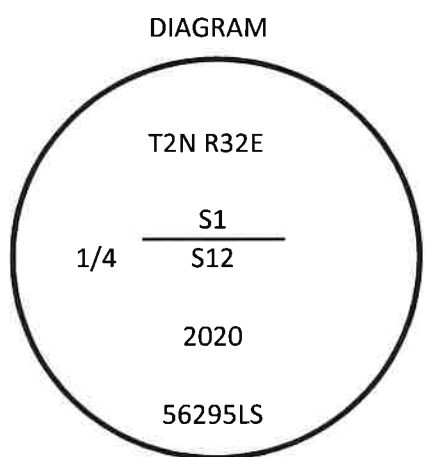
The 1/2" iron rod set southwesterly of the Krumbein proportioned point in good condition. There was a hole in the concrete slab where the brass cap set under survey 88-19-C was scraped out by clean up activities after the January flood this spring. At the true corner position identified by ties to the plats of Pierce's Home tracts and Lassen Addition I found a basalt stone, 11x9x7 inches with an "x" on top. At this point I also found a badly rusted bolt with survey flagging attached, all of which was under the concrete slab at space 49 of the Riverview Estates Mobile Home Park. The stone and bolt appeared to be slightly disturbed.

At the position of the original corner calculated from ties to Pierce's Home Tracts I set a 2 1/4" Brass Cap on a 1 1/2" galvanized iron pipe 3" below the surface of the concrete slab. I buried the stone and rusted bolt along the east side of the pipe.
