9-11

OREGON CORNER RESTORATION FORM

Section 9 Township 2N Range 33E

County Umatilla Date Jan. 1994

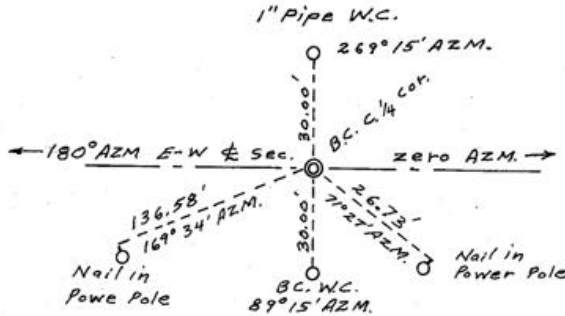
Sketch

Found $2\frac{1}{2}$ " Brass cap W. C. on 1" Pipe 30.00 ft. south of corner. Found 1" Pipe that had a brass cap 30.00 ft. North that is another W.C.

corner approximately 2 ft. S. of centerline of paving

Set $2\frac{1}{2}$ " brass cap on 1" x 30" G.I.P. 6" below surface of paving in a cast iron monument box with lid.

1. Set alum. nail in middle of a bearing object sign on E. face of Power Pole S. E. 26.73 ft. from the corner.
2. Set Alum. nail in middle of a bearing object sign on N. W. face of power pole S. W. 136.58 ft. from the corner.
