OREGON CORNER RESTORATION FORM

Section 3 Township 2S Range 32E
 County Umatilla Date: April 25, 1997

Corner Designation: 2S32 E15

1/4 Corner to sections 3, and 10 T2S, R32E W.M.

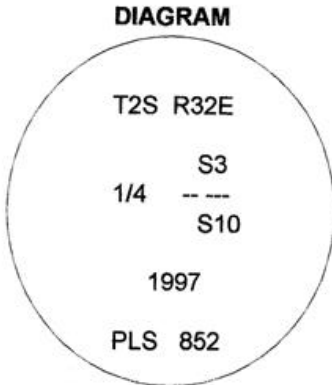
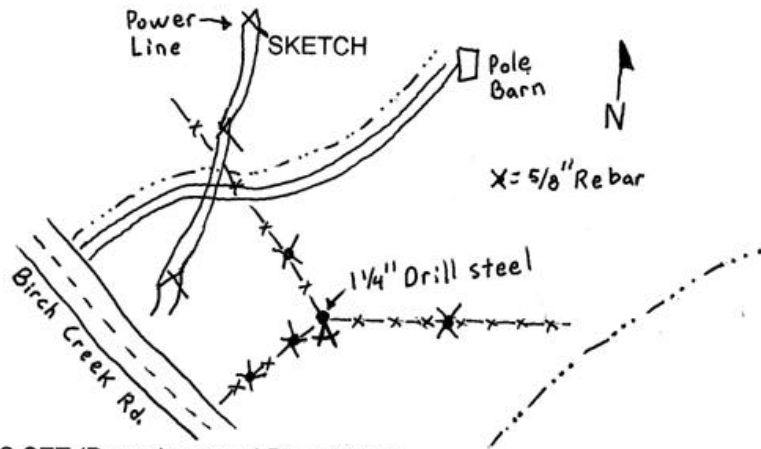
A fence intersection with fences running East, Northwest, and Southwest. The post in the fence corner has a Umatilla County Surveyors Sign on it reporting it to be the corner. There is no date on the sign.

Set a 1 1/4" x 30" hollow drill steel at the fence corner. Drove the steel into the bedrock.

For references, I set four 5/8" by 24" rebars with 1.25" red plastic caps stamped ORLS 852 and WAL5 13922 as described below:

- a rebar bears N26°15'W, 93.07 feet under the existing fence;
- a rebar bears S42°20'W, 34.48 feet under the existing fence;
- a rebar bears S42°28'W, 72.05 feet under the existing fence;
- a rebar bears N87°55'E, 55.48 feet under the existing fence;
