**OREGON CORNER RESTORATION FORM**

Section 10 Township 3N Range 27E  
 County Umatilla Date 07-18-02

Corner Designation: 8N27J45

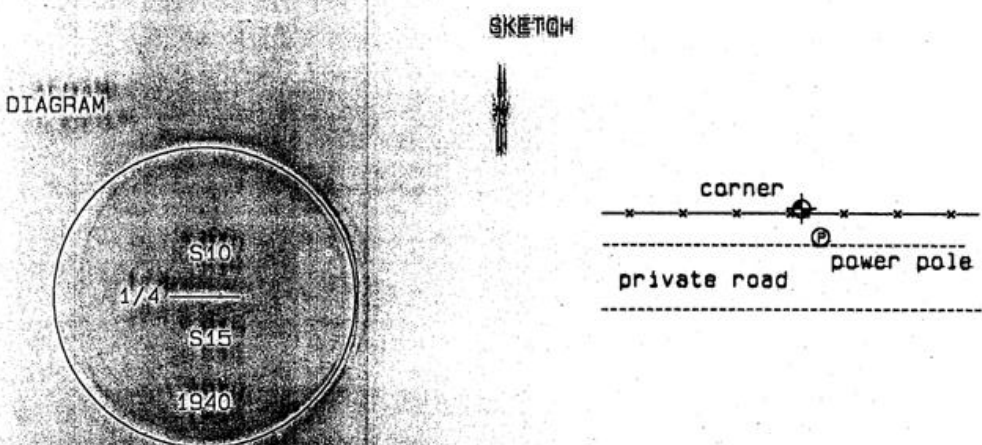
Monument and Accessories Found: (condition and source)  
 Found standard GLO brass cap on 1" iron pipe in north south fence line.  
 Corner is bent at a point about 12" below surface. Shot at apparent center of lower part of pipe.
