CORNER RESTORATION FORM

Township 3N Range 28E Section 7 County UMATILLA

Corner Designation : SOUTHWEST CORNER

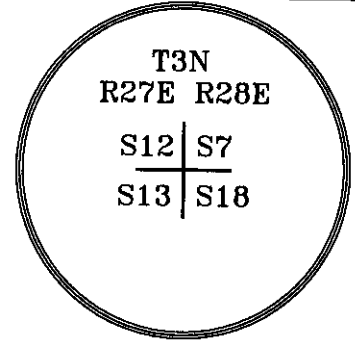
MONUMENT DETAIL

FOUND BADLY BENT 2 IN. IRON PIPE WITH NO
CAP. PIPE WAS STRAIGHTENED AND RESET IN
FOUND POSITION. MONUMENT IS NOTED IN
RECORD OF SURVEY FILED AS 00-33-B UMATILLA
COUNTY SURVEY RECORDS.

DETAIL IS FOR
REFERENCE ONLY
CAP WAS MISSING

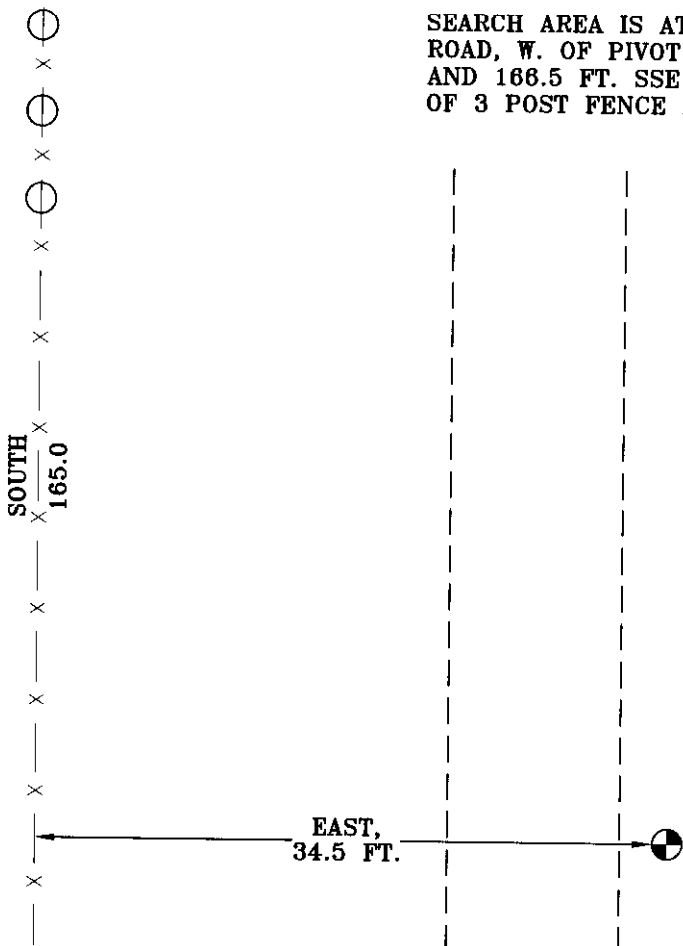
Sketch of Monument, Accessories and General Area

SEARCH AREA IS AT E. EDGE OF
ROAD, W. OF PIVOT IRR. FIELD
AND 166.5 FT. SSE OF S. POST
OF 3 POST FENCE BRACE
