**OREGON CORNER RESTORATION FORM**

Section 2 Township 3N Range 33E  
County Umatilla Date: 03/25/11

Corner Designation: 3N33A19

1/4 corner common to sections 35, T4NR33E, 2, T3NR33E.

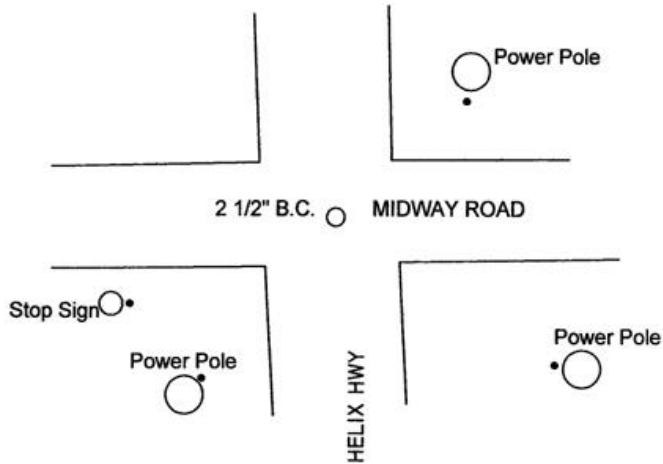
Sketch

A 2 1/2" B.C. 4" below oil mat surfaced road. (Helix Hwy)  
A 5/8" iron rebar, lying N 43°40' E, 41.73'.

The corner is in the intersection of Helix Hwy. and Midway Road.

- A 5/8" x 30" iron rebar w/rpc #43406, lies S 78° E, 90.66', at a power pole.
- A 5/8" x 30" iron rebar w/rpc #43406, lies S 20°20' W, 64.06', at a power pole.
- A 5/8" x 30" iron rebar w/rpc #43406, lies S 71°30' W, 60.70', at a stop sign.
