OREGON CORNER RESTORATION FORM

Section 2,3 Township 3N
County Umatilla Date: 03/25/11

Corner Designation: 3N33C17

Corner common to sections 2,3 T3NR33E.

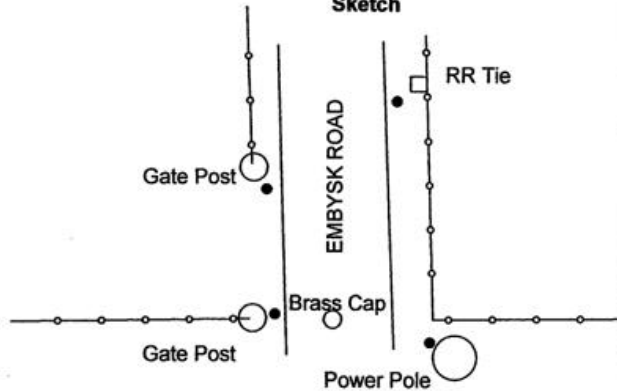
Sketch

None.

A 1 1/4" x 30" galvanized iron pipe with a 2 1/2" brass capped monument, 10" below the surface, stamped as shown above. There is an ancient existing East - West fence that I held for Northing, and placed the monument on line between the two found corners North and South.

- A 5/8" x 30" iron rebar w/rpc #43406, lies N 19° W, 34.25', at a Gate Post.
- A 5/8" x 30" iron rebar w/rpc #43406, lies N 19°15' E, 68.70', at a RR Tie fence post.
- A 5/8" x 30" iron rebar w/rpc #43406, lies S 88° E, 24.74', at a Power pole.
- A 5/8" x 30" iron rebar w/rpc #43406, lies S 86° W, 9.86', at a gate post.
