OREGON CORNER RESTORATION FORM

Section: 2, 11 Township: 3N Range: 33E
County: Umatilla Date: 4/11/2012

Corner Designation: 3N33E19

Quarter corner common to Sections 2, 11, T3NR33E.

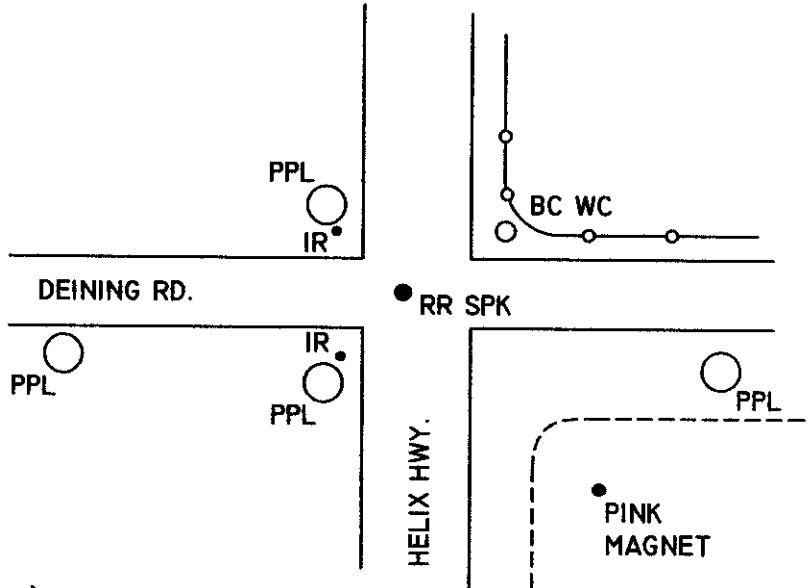
Sketch

A railroad spike at the corner position, in the South bound lane of the Helix Hwy. at the intersection with the centerline of Deining Rd.

The corner location was reestablished by single proportionate method between neighboring corners to the East and West.

- A 5/8" x 30" iron rebar w/ RPC #43406 lies N 23° 40' W, 46.39', at a power pole.
- A 1 1/8" galvanized iron pipe with 2 1/2" brass cap Witness Corner lies N 45° 50' E, 43.01', at the surface.
- A pink "Deep One" magnet by Berntsen lies S 48° 50' E, 58.29', 1.6' deep.
- A 5/8" x 30" iron rebar w/ RPC #43406 lies S 24° 10' W, 41.39', at a power pole.

The corner is located in the South bound lane of the Helix Hwy. at the intersection with Deining Rd.
