OREGON CORNER RESTORATION FORM

Corner Designation: 3N33N9

Corner common to sections 16,17,20 and 21, T3NR33E.

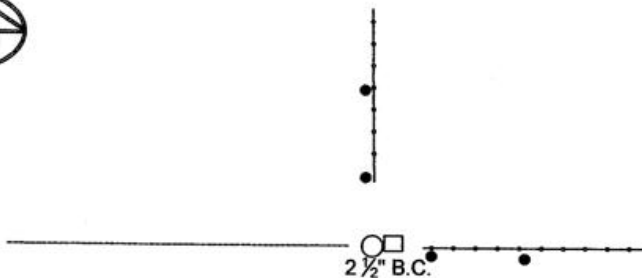
Sketch

- A 2 1/2" Brass Cap, as stamped below.
- A 5/8" iron rebar w/rpc #1106, lies N 04° E, 26.9'.
- A 5/8" iron rebar w/rpc #1106, lies N 04° E, 53.6'.
- A 5/8" iron rebar w/rpc #1106, lies S 86° E, 16.9'.
- A 5/8" iron rebar w/rpc #1106, lies S 86° E, 40.9'.

Located at a fence corner in the edge of two fields, 0.5 miles East of Myrick Road.
