OREGON CORNER RESTORATION FORM

Section: 19, 20, 29, 30 Township: 3N Range: 33E
 County: Umatilla Date: 6/1/2011

Corner Designation: 3N33R05

Section corner common to Sections 19, 20, 29, 30, T3NR33E.

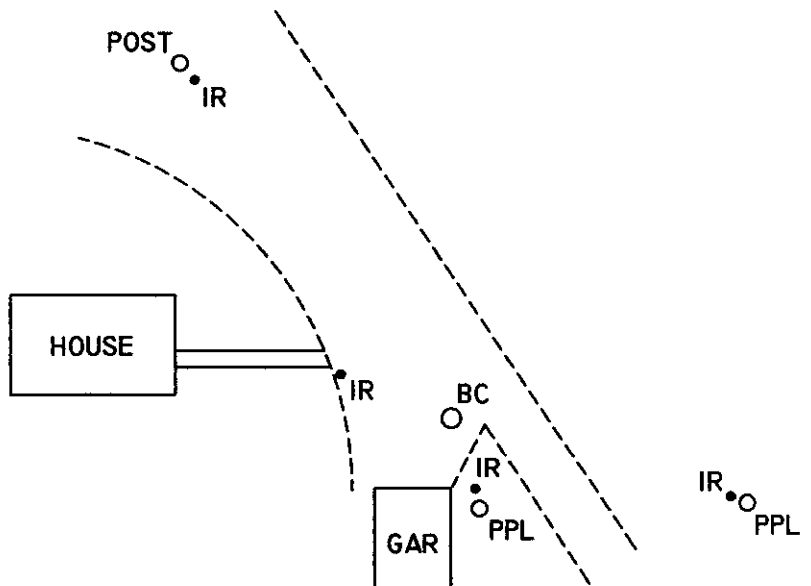
Sketch

A 1 1/8" x 30" galvanized iron pipe with a 2 1/2" brass cap, stamped as shown above, 1.3' below the surface. The corner location was reestablished by double proportionate method with good fit to field lines North and East.
