OREGON CORNER RESTORATION FORM

Section 33 Township 4N Range 29E

County Umatilla Date 4/25/96

C 1/4

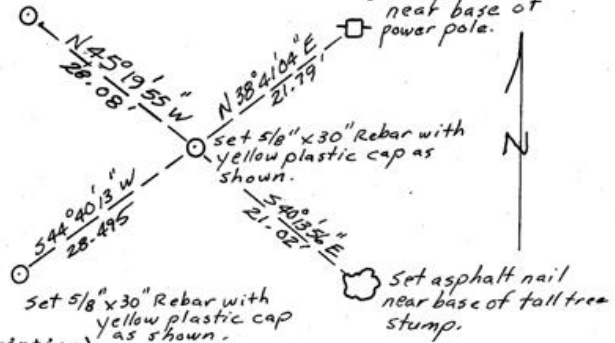
Monument Detail

set 5/8" x 30" rebar with yellow plastic cap as shown.

Yellow Plastic Cap (1 1/4" Diameter) On 5/8" x 30" Rebar

Set 5/8" x 30" rebar 4" beneath gravel road surface with yellow plastic cap marked as shown above. Monument was set by traversing through opposite 1/4 corners and intersecting lines between them.
