**SUBJECT**: Replace courthouse main roof

# **Umatilla Courthouse**

Job # Roof Cores

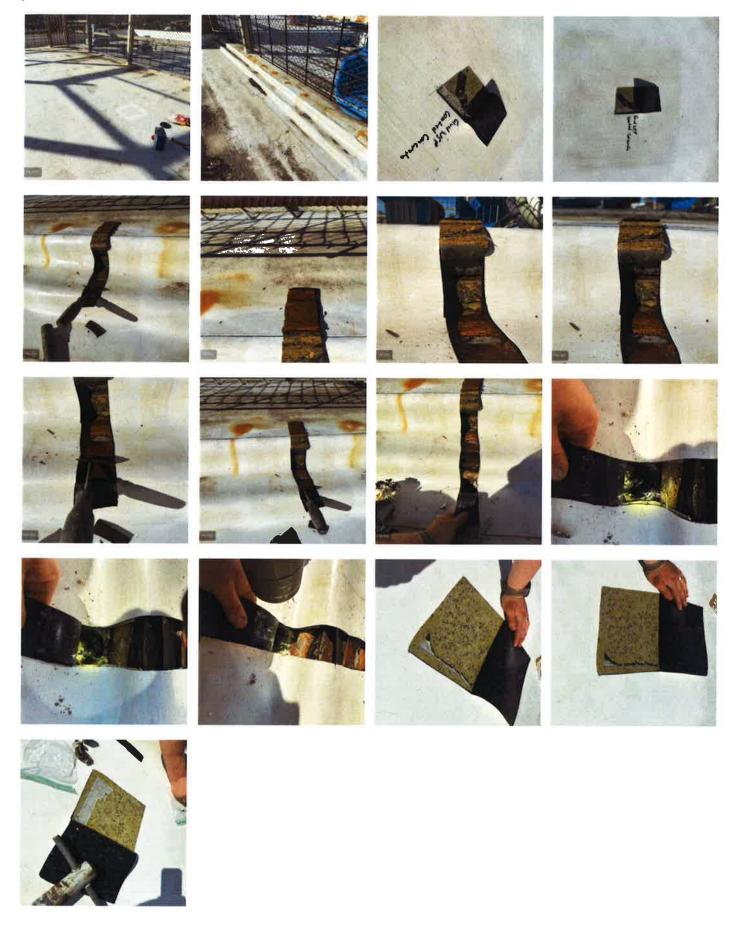
**Transition Core:** Adhered white single ply Adhered EPDM High step is Concrete.

Low step has wood blocking with a term bar in the middle.

There is yellow fiberglass insulation on the base of the lower wall as well.

Completely saturated with wood block rotting.

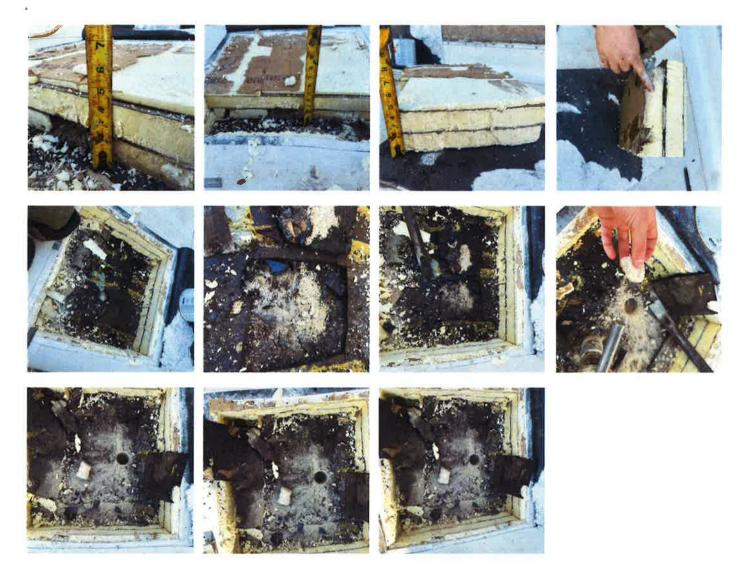
## 5. Main Roof Field Cut Out 1 (High side)

2'x2' Cut Out: Fully adhered white single ply 1/4" Gypsum Board 2 layers of 2" Polyiso (With Tapered Package) 3 ply BUR Lightweight Concrete Deck that is 4" deep

In this area there is also a squared off section of hard concrete.
