U. S. Department of Agriculture
FOREST SERVICE

Umatilla NATIONAL FOREST

CORNERS OF THE PUBLIC SURVEY

CORNER RECORD (SEARCH)

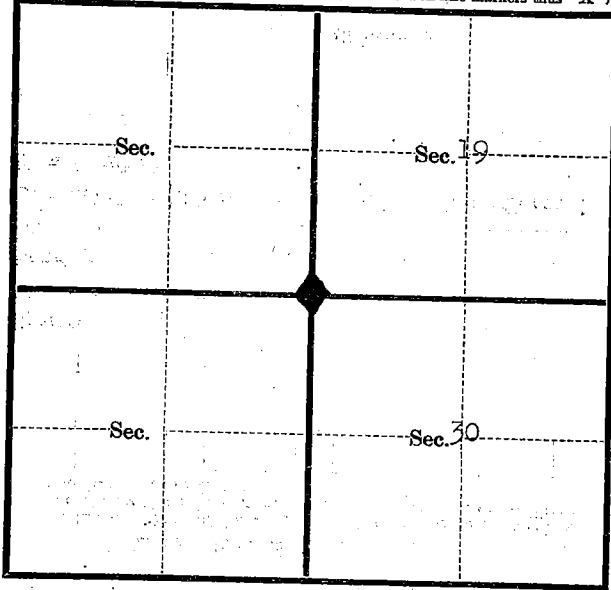
Do you believe this to be a genuine Land Office Corner? ...
If not, why? Yes, original scribe.
Original post in place. Rotted, but scribing evident.

Give any further facts needed to find Corner again:

Line blazed.

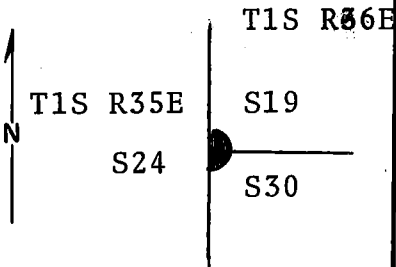
CORNER DIAGRAM

Set brass cap summer 1972. See reverse side.

Found a 20" fir stump rotted off at ground level with faint scribing visible, bearing S81°W 15.2 ft. dist. from corner position.

Found rotten remains of a tamarack with scribing visible, bearing S49°E 16.5 ft. dist. from the corner position.

Found the rotten remains fo a tamarack, bearing N47°E

16.5 ft. dist. from the corner position
Found a rotten fir stump, bearing N58°W 9.9 ft. dist. from the corner position.

Set a 30x2½" iron pipe with 3" brass cap marked as shown, 28" in the ground for the corner to secs 19, 30, & 24 from which new BTs:

- A tamarack 10" dia. bears N17°E 12.8 ft. dist. marked T18 R36E S19 BT.
- A lodgepole pine 10" dia bears S42°E 12.7 ft. dist. marked T1S R36E S30 BT.
- A ponderosa pine 12" dia. bears S10°W 13.6 ft. dist. marked T1S R35E S24 BT.

All distances taken to a brass washer in the blaze of each tree.

Set a steel fence post approx. 5 ft East from corner with "Attention" sign attached, Used steel tape & magnetic compass with declination = 20°E.
