# RECORD OF LAND CORNER MONUMENTATION

NORTH SIXTEENTH CORNER OF SECTION 17, T. 4 S., R. 32 E., W.M.

24-077-6

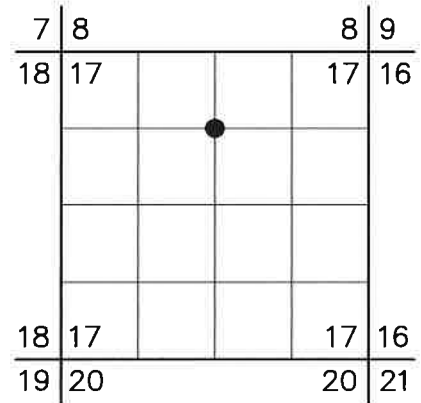
Set 2½" x 30" galvanized pipe with brass cap marked (diagram shown):  
Set pipe 6" in the ground to bedrock and mound of stone around to cap.

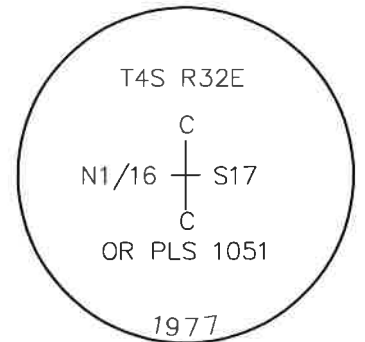
CORNER MONUMENT MARKED:

Found a 2½" galvanized iron pipe with a 2½" brass cap, marked as shown on the diagram, projecting 23" above ground in loose mound of stone with 4 ft. base. A steel gate post set in concrete, with fence lines extending west and south, is 2 ft. east and approximately 250 ft. east of Forest Service Road # 5412-130.

I accept the position of the found monument, and rebuild the mound of stone, with a 4 ft. base and 17" tall.
