M-64
Sheet 1 of 5

KRUMBEIN ENGINEERING CO. ENGINEERS - SURVEYORS - PLANNERS 221 S. Main, Pendleton, Oregon	SCALE 1"=500'
	DATE June 14, 1977
Survey for U.S. FOREST SERVICE Section 1, T6S, R30E W.M.	DRN BY P.L.S.
	CKD BY T.E.H.
	DRWG NO. 77-360

K KRUMBEIN ENGINEERING CO ENGINEERS - SURVEYORS - PLANNERS 221 S. Main, Pendleton, Oregon	SCALE 1"=500'
	DATE June 14, 1977
Survey for U.S. FOREST SERVICE Section 2, T6S, R30E W.M.	DRN. BY D.S.
	CKD. BY T.E.H.
	DRNG. NO. 77-36C

KRUMBAIN ENGINEERING CO ENGINEERS - SURVEYORS - PLANNERS 221 S. Main, Pendleton, Oregon	SCALE 1" = 500'
	DATE May 19, 1977
Survey for U.S. FOREST SERVICE Section 3, T6S, R30E W.M.	DRAWN BY P.L.S.
	CHECKED BY T.E.H.
	DRWG. NO. 77-36C

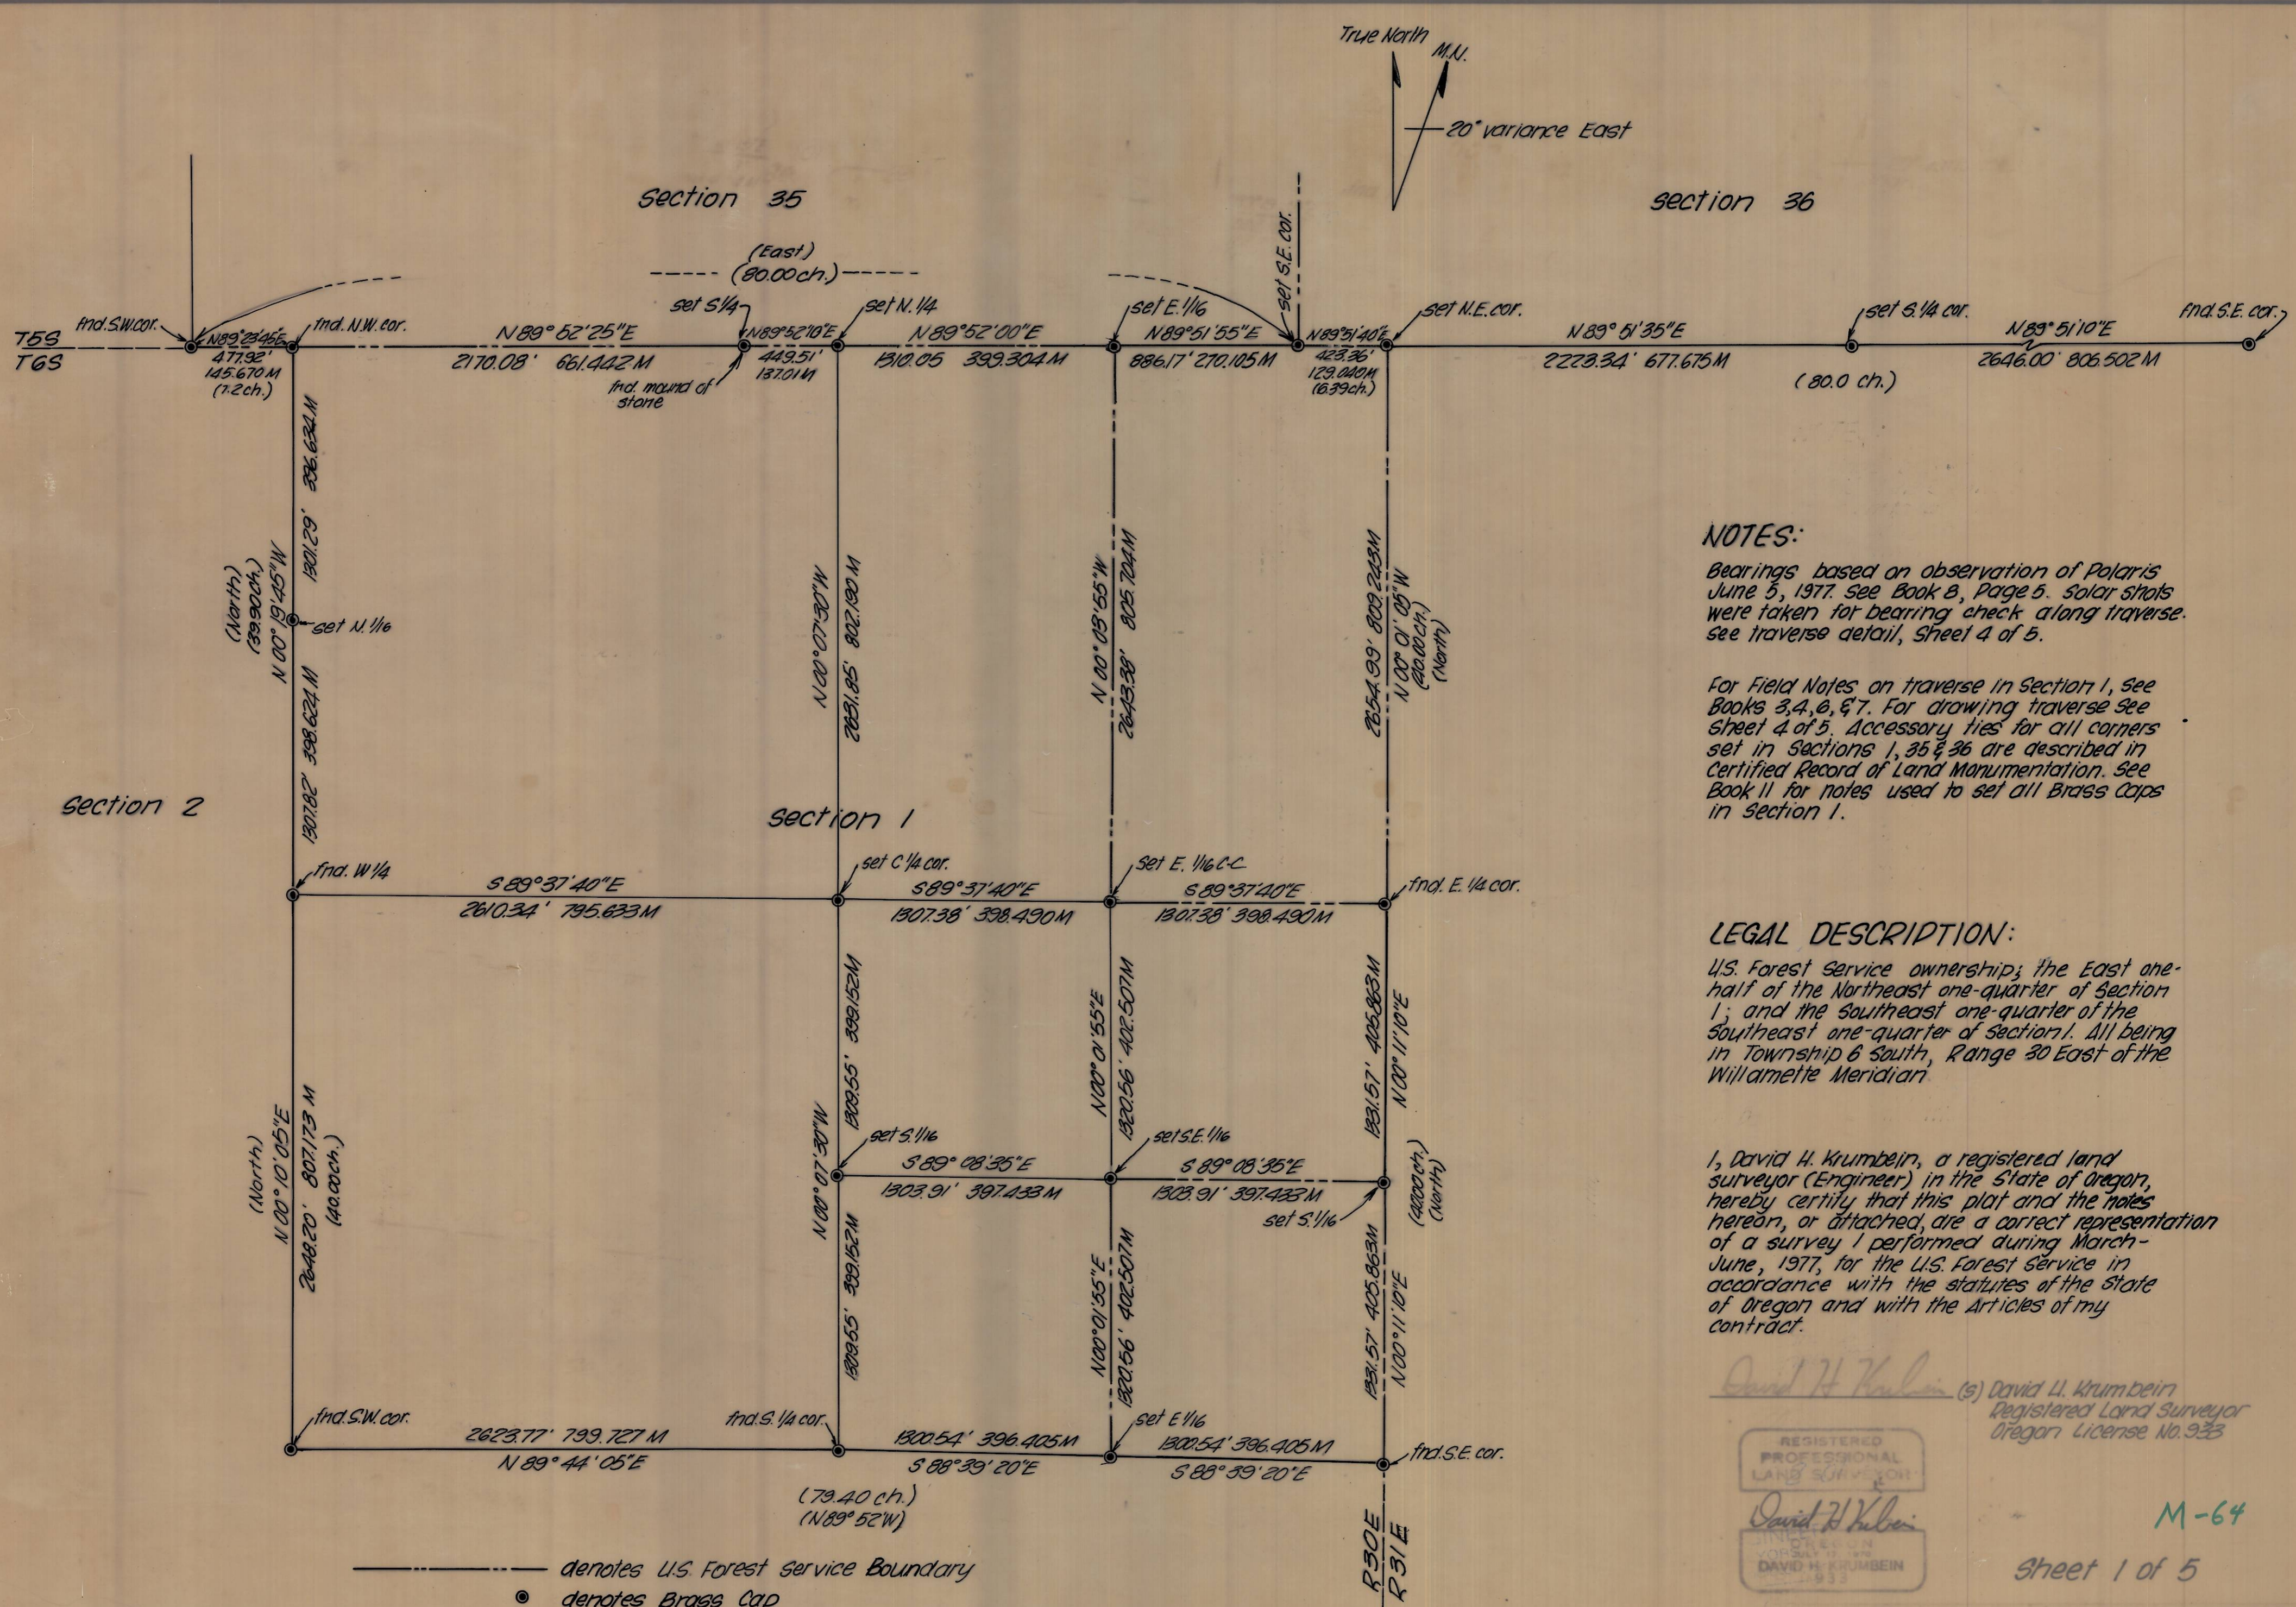
Bearings based on observation of Polaris June 5, 1977. See Book B, Page 5. Solar shots were taken for bearing check along traverse. See traverse detail, Sheet 4 of 5.

For Field Notes on traverse in Section 1, See Books 3, 4, 6, & 7. For drawing traverse See Sheet 4 of 5. Accessory ties for all corners set in Sections 1, 35 & 36 are described in Certified Record of Land Monumentation. See Book 11 for notes used to set all Brass Caps in Section 1.

U.S. Forest Service ownership; the East one-half of the Northeast one-quarter of Section 1; and the Southeast one-quarter of Section 1. All being in Township 6 South, Range 30 East of the Willamette Meridian

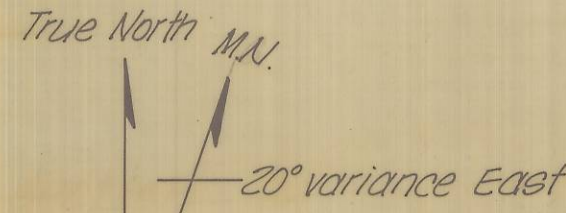
Sheet 2 of 5

NOTES:
 Bearings based on observation of Polaris June 5, 1977. See Book 3, Page 5. Solar shots were taken for bearing check along traverse. See traverse detail, Sheet 4 of 5.

For Field Notes on traverses in Section 2 See Books 3, 4, 5, & 6. For drawing of traverse see sheet 4 of 5. Accessory ties for all corners in Sections 2 & 34 are described in Certified Record of Land Monumentation. See Book 10 for notes used to set all Brass caps in section 2.

The South one-quarter corner of section 34 appears to be out of its proper location, so based on "Manual of Surveying Instructions" section 3-37, page 70, this corner was not used for computing corners in section 2.

- denotes U.S. Forest Service boundary
- denotes Brass Cap
- () denotes G.L.D. record bearings & distances

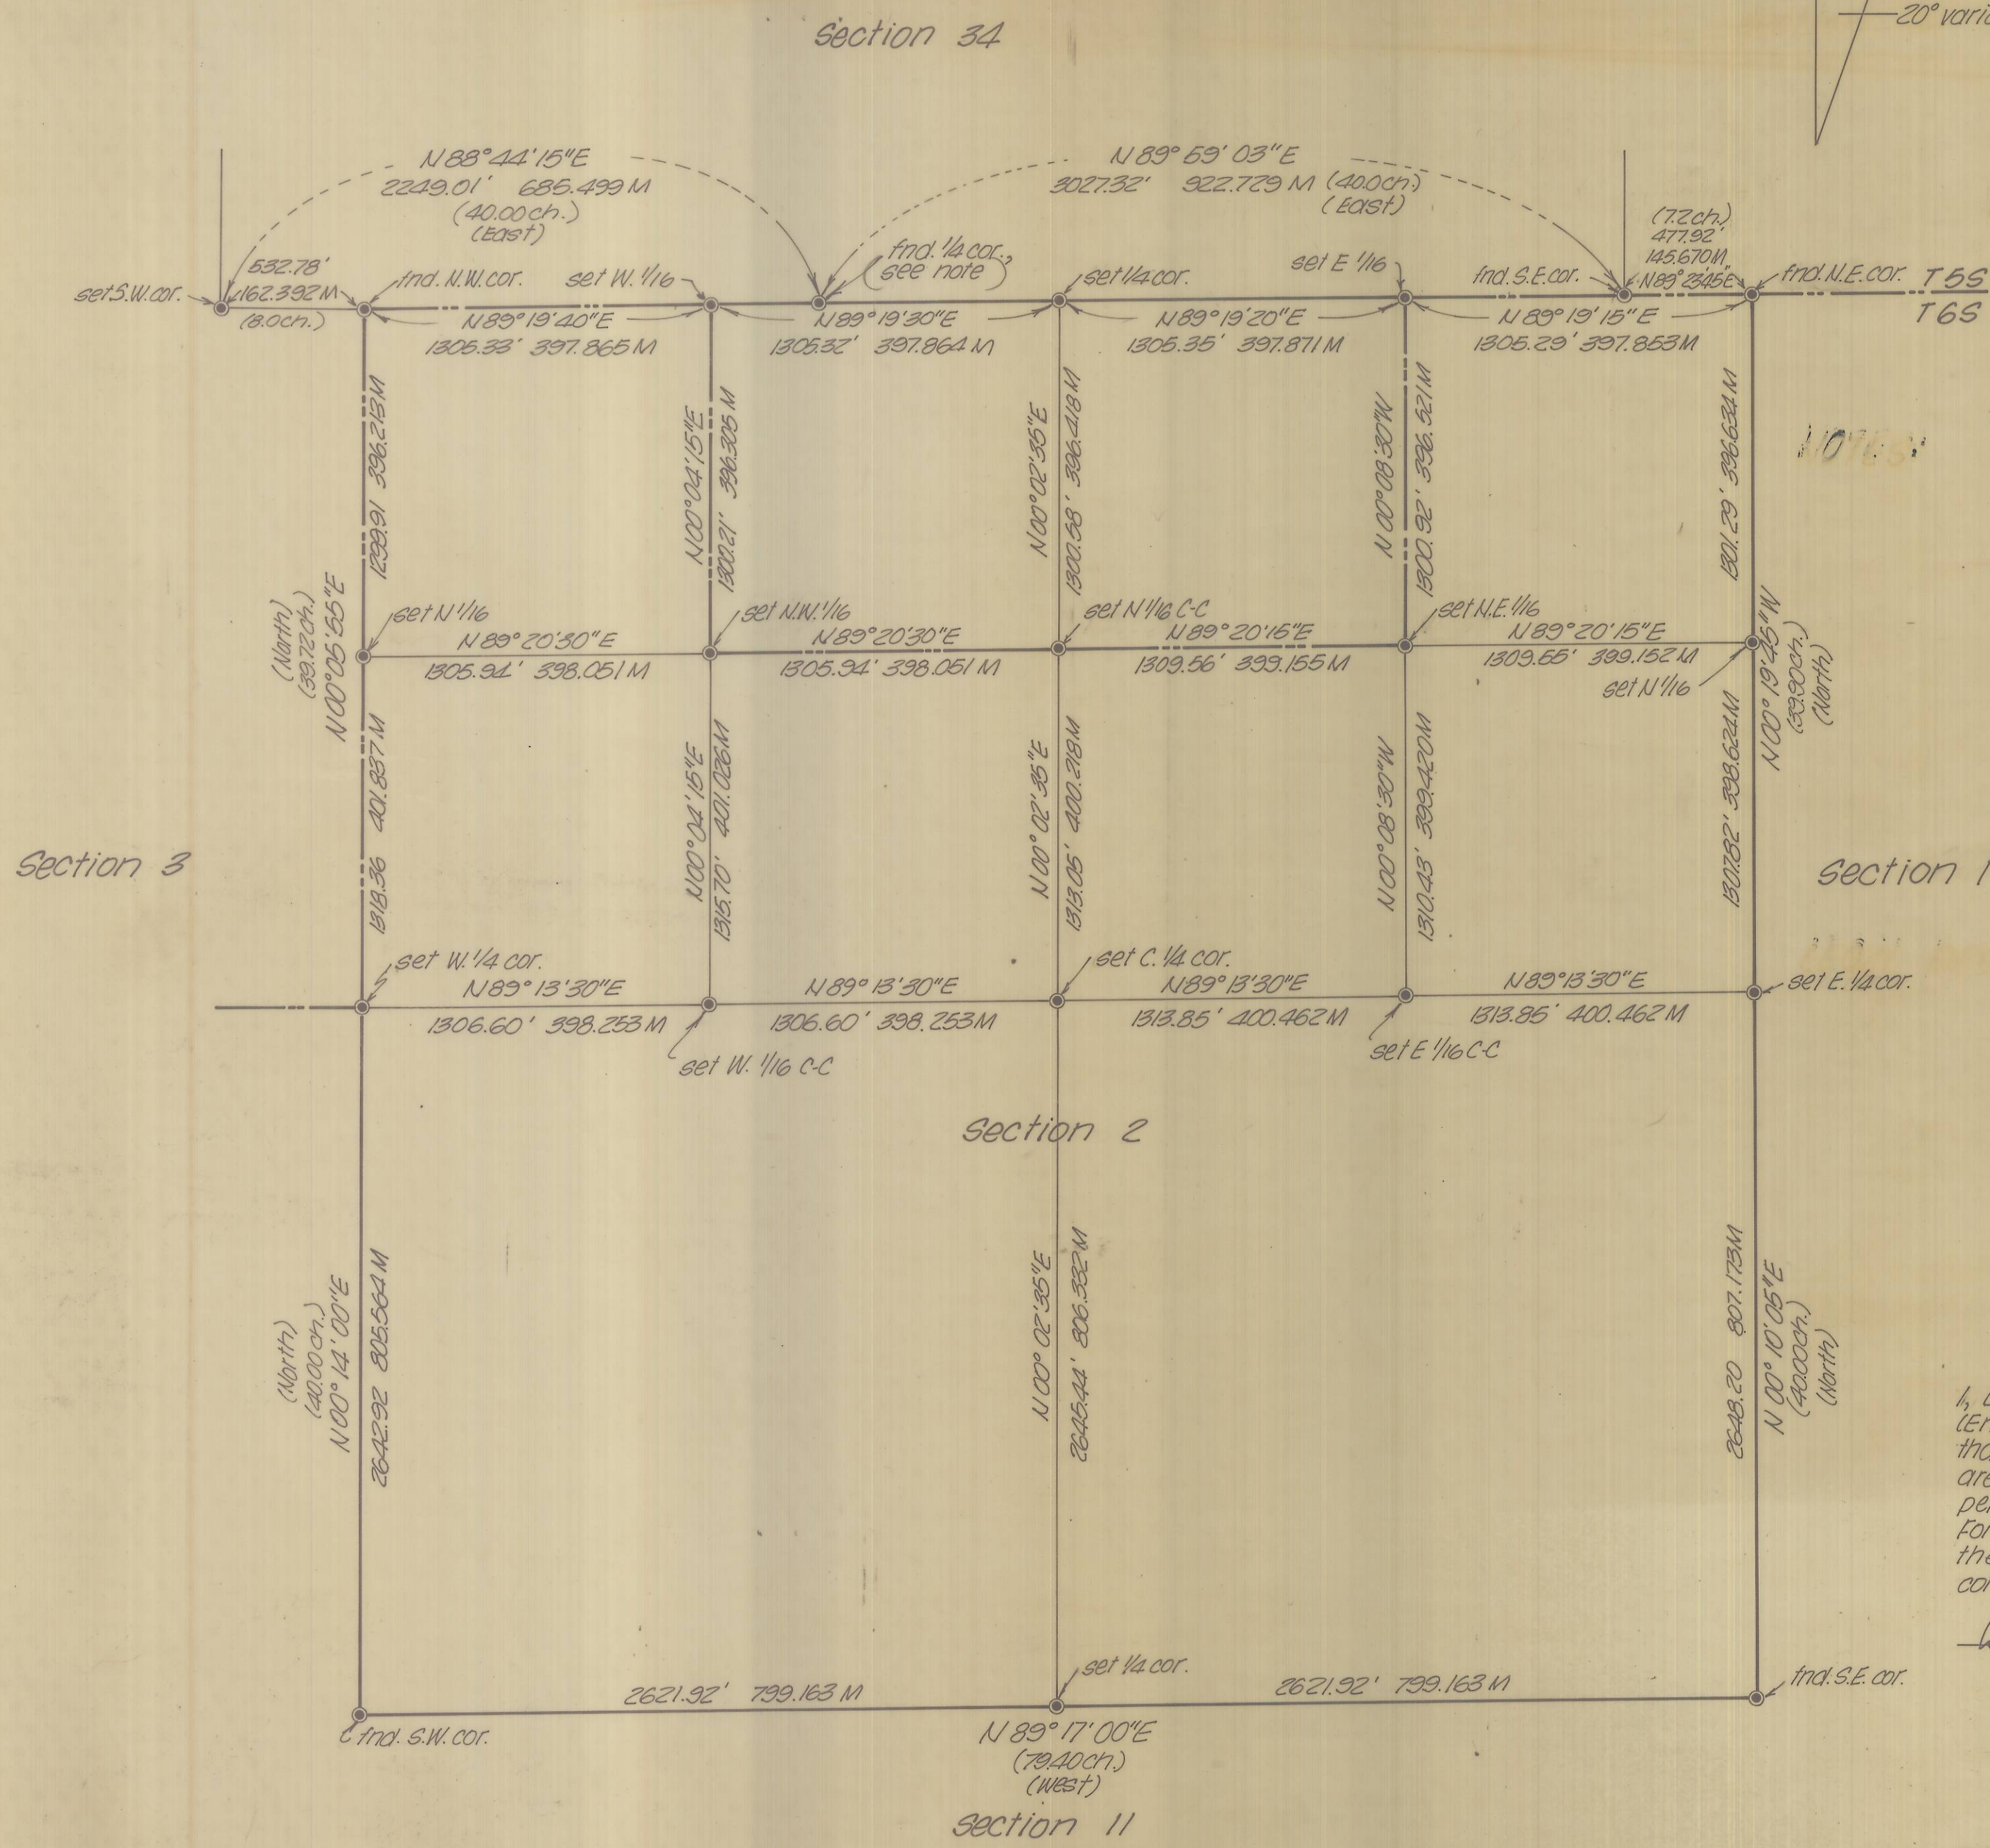
LEGAL DESCRIPTION:
 U.S. Forest Service ownership; the Northeast one-quarter of the Northwest one-quarter of Section 2, and the Northwest one-quarter of the Northeast one-quarter of Section 2. All being in Township 6 South, Range 30 East of the Willamette Meridian.

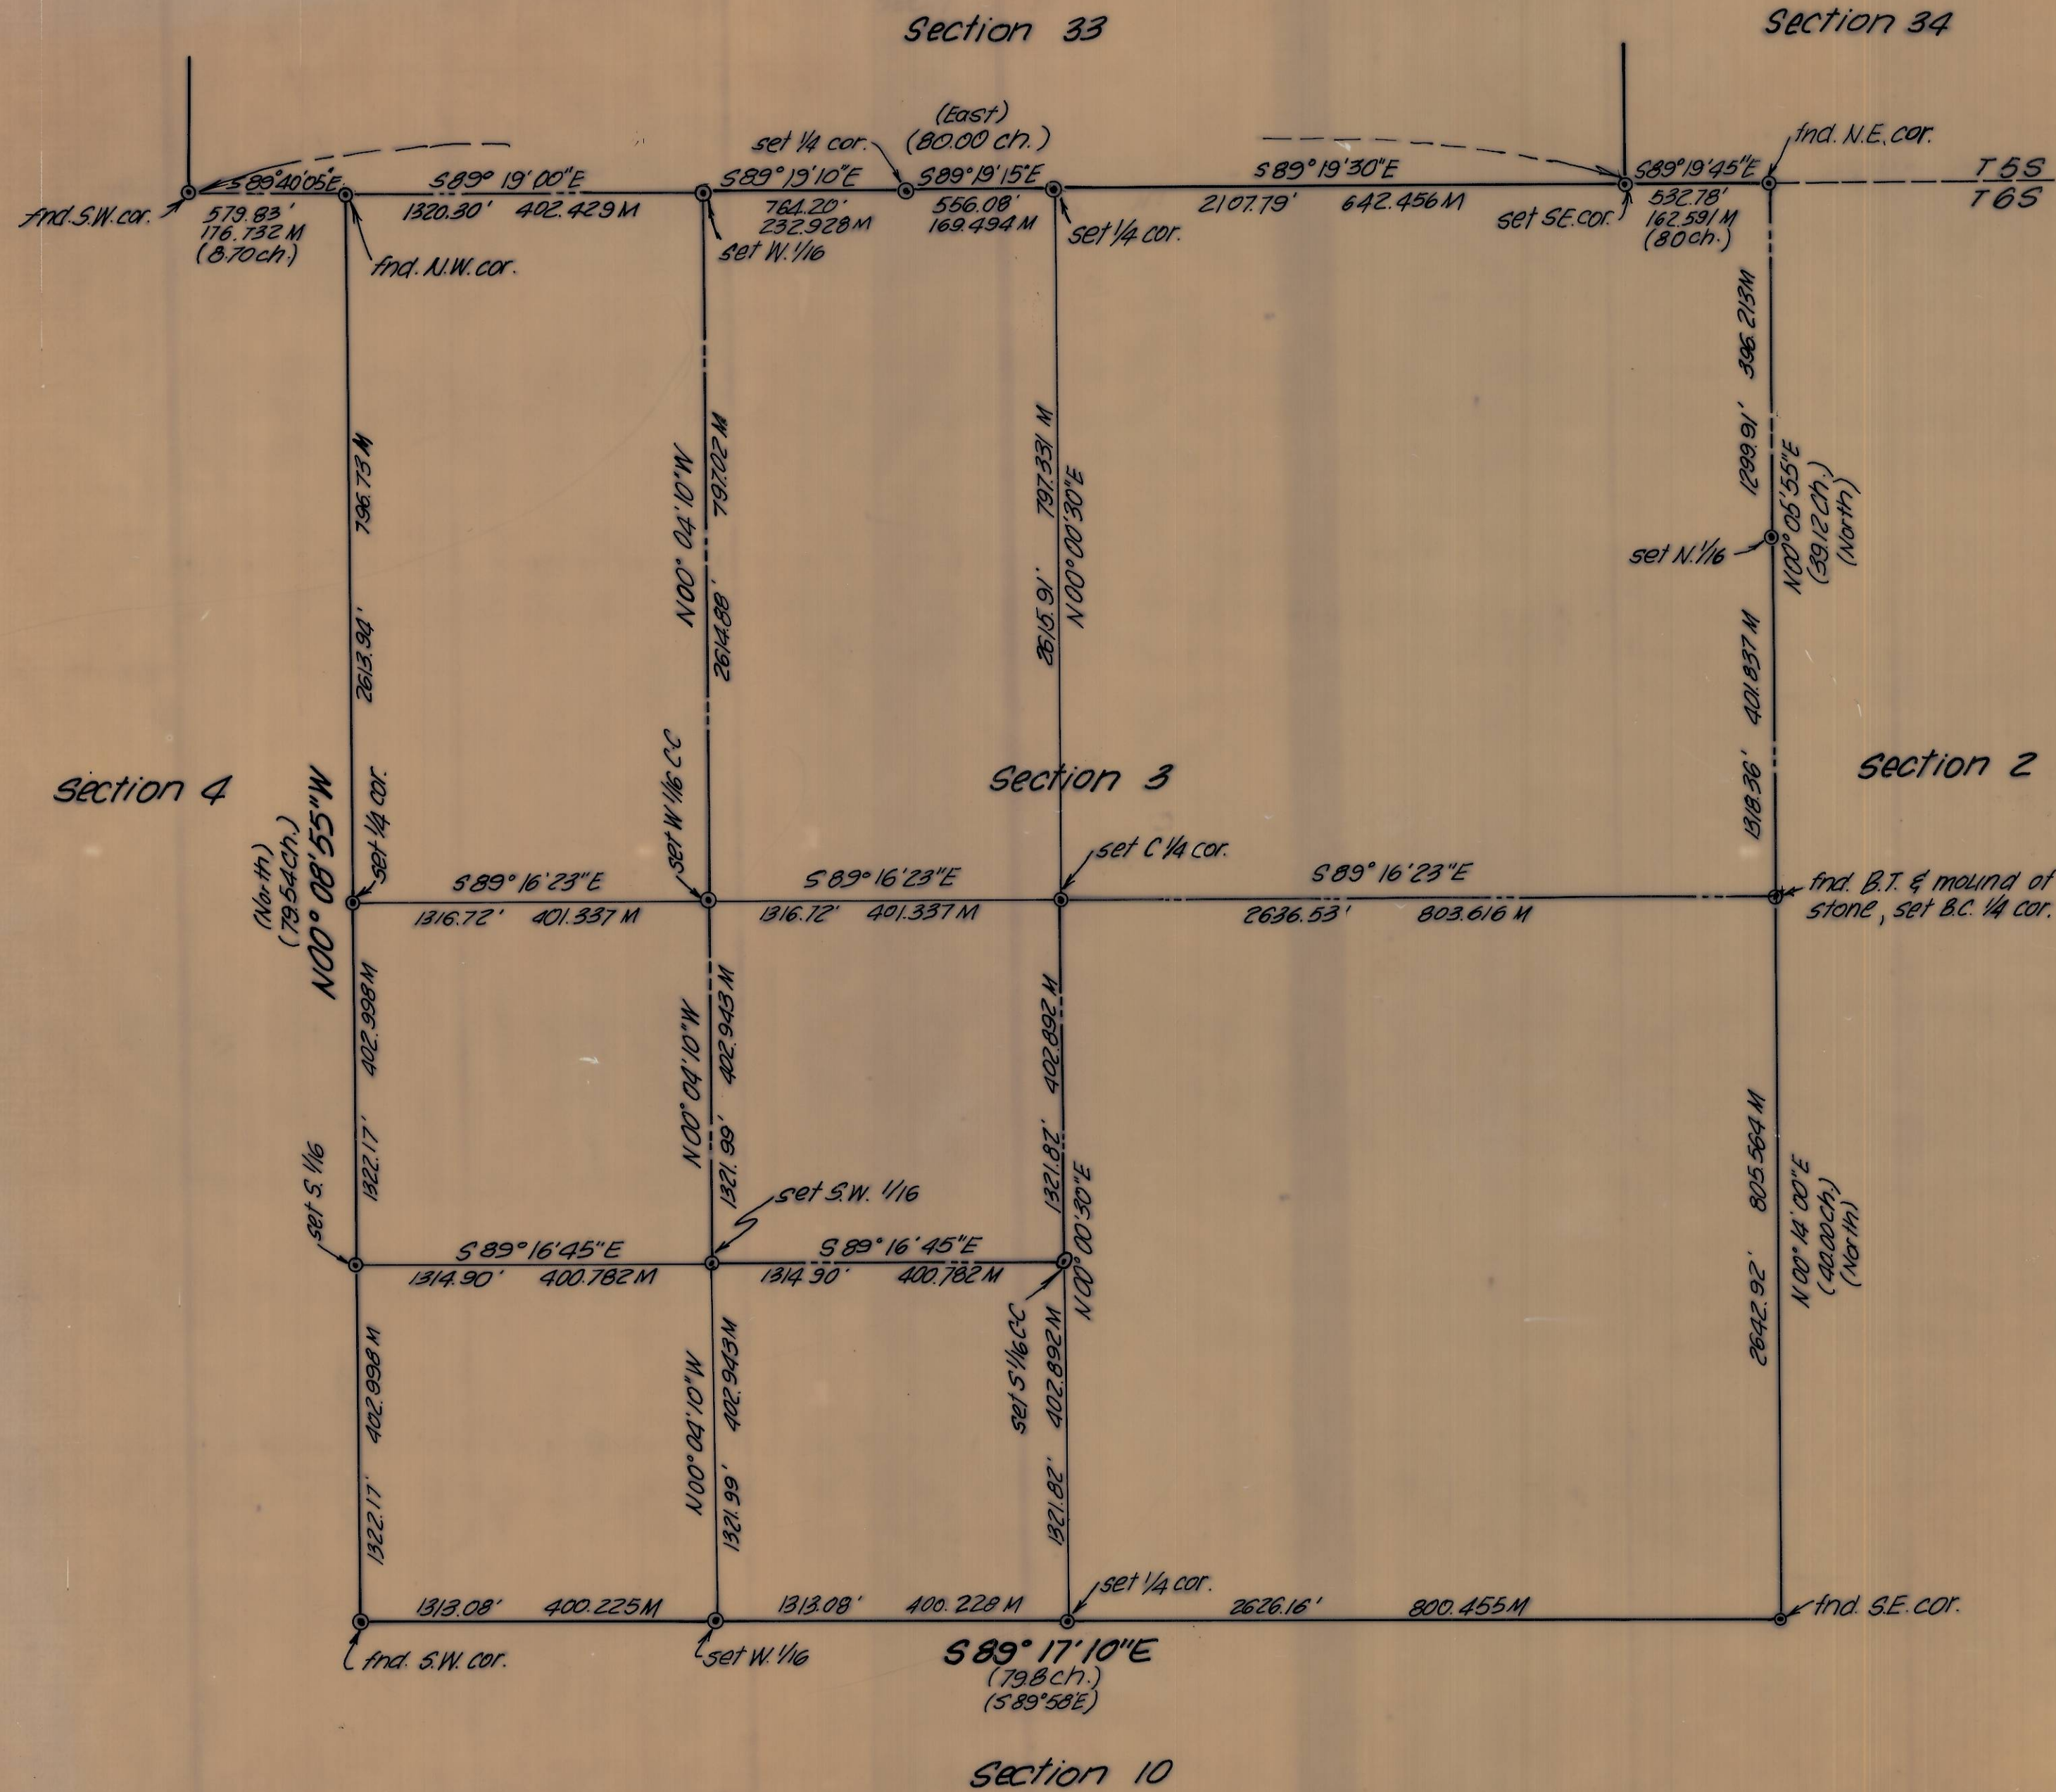
Sheet 3 of 5

Bearings based on observation of Polaris, June 5, 1977. See Book 8, Page 5. Solar shots were taken for bearing check along traverse. See traverse detail, Sheet 5 of 5.

For Field Notes on traverses in Section 3 see Books 1 & 2, and first half of Book 3. For drawing of traverse see Sheet 5 of 5. Accessory ties for all corners in Sections 3 & 33 are described in Certified Record of Land Corner Monumentation. See Book 9 for notes used to set all Brass Caps in Section 3.

U.S. Forest Service ownership; the East one-half of the Northwest one-quarter of Section 3, and the Northeast one-quarter of the Southwest one-quarter of Section 3, and the Northeast one-quarter of Section 3. All being in Township 6 South, Range 30 East of the Willamette Meridian.
