Umatilla NATIONAL FOREST

CORNERS OF THE PUBLIC SURVEY

T. 1 N. R. 35 E Will. Mer.

Section 23, 24, 25, and 26 Corner common to Sections

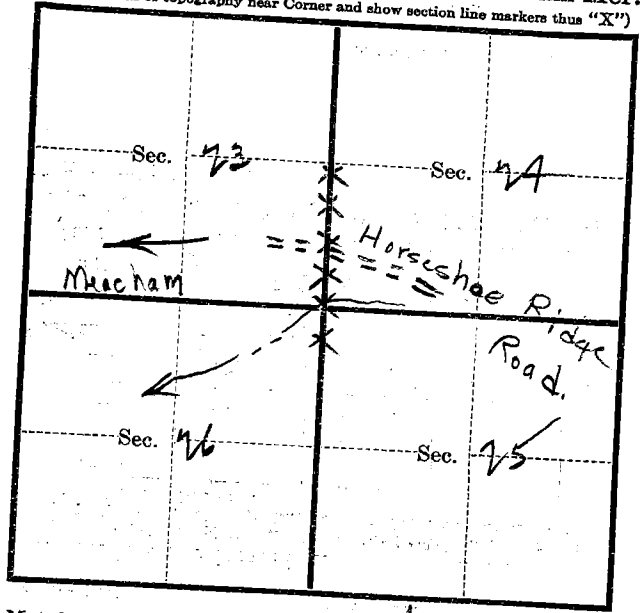
T. 1 N. R. 35 E Will. Mer.  
 (Make sketch of topography near Corner and show section line markers thus "X")

Metal Location Poster is on a White Fir  
 tree 4 inches diameter, on the West  
 side of line fence from which  
 this Corner bears N 3/4 E, 0.10 Chains.  
 (Bearing) (Distance)  
 Section line marker between Secs. 43 and 44 is on  
 a tree on the road  
 (Tree, post, etc.) (Name of road, trail, etc.)  
 located 0.10 chains E, W, N, S, from Sec. Cor.; 1/4 Cor.; Witness Cor.  
 (Cross out nonapplicable)

3" Square stake  
driven alongside  
old G.L.O. stake.  
Cruiser's tag on  
fence post at Horseshoe  
Ridge Road - 17.83 Chs  
North  
of Cor.
