CORNER RECORD (SEARCH)

T 1 N R. 36E
Merid. Willamette

R.D. Pendleton County Umatilla
N.F. Umatilla State Oregon

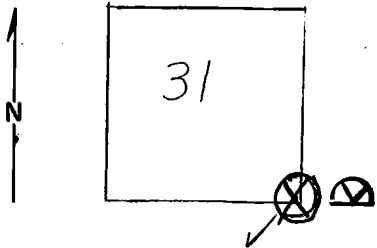
CORNER DIAGRAM

None found.

Ponderosa pine BT (7' high snag) bears S80°W 83 LKs from corner; DBH is 26".
No evidence of other BTs.

Found corner by walking east of the Crow Ridge Road where the baseline crosses the road. Corner is about 300 ft. below top of Crow Ridge and is in a clearing.

Posted "BT" and attention "signs".
 Flagged (red) and painted (red) BT.
 Chained west to Crow Ridge Rd. approx. 8 1/2 chains; Posted corner location tag.
