OREGON CORNER RESTORATION FORM

CORNER DESIGNATION: T1S, R31E, P-01

WEST QUARTER CORNER OF SECTION 19, TOWNSHIP 1 SOUTH, RANGE 31 EAST, W.M.,
UMATILLA COUNTY, OREGON.

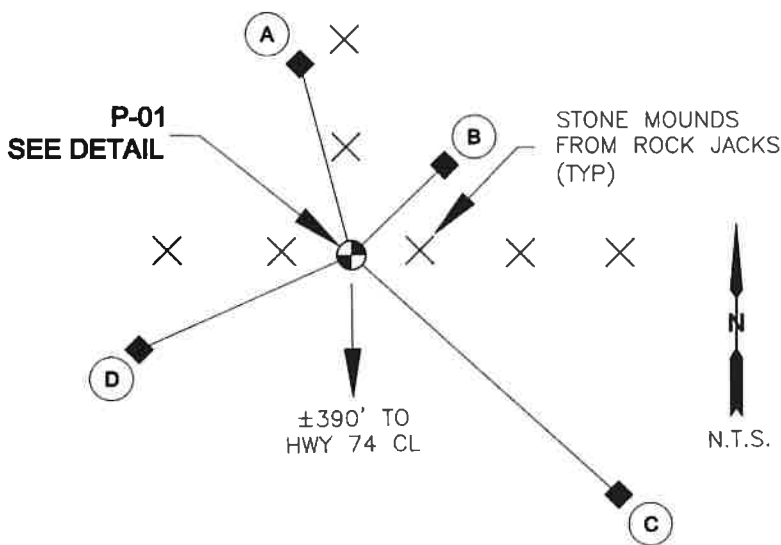
DIAGRAM:

- (A) SET 5/8" X 30" STEEL REBAR MARKED "UCPWD LS89374" BEARING OBJECT SIGN ATTACHED TO REBAR. CORNER BEARS S 15° E, 82.5'.
- (B) SET 5/8" X 24" STEEL REBAR MARKED "UCPWD LS89374" BEARING OBJECT SIGN ATTACHED TO REBAR. CORNER BEARS S 46° W, 53.8'.
- (C) SET 5/8" X 30" STEEL REBAR MARKED "UCPWD LS89374" BEARING OBJECT SIGN ATTACHED TO REBAR. CORNER BEARS N 48° W, 149.5'.
- (D) SET 5/8" X 30" STEEL REBAR MARKED "UCPWD LS89374" BEARING OBJECT SIGN ATTACHED TO REBAR. CORNER BEARS N 66° E, 96.3'.

AT THE LOCATION OF THE PITTED STONE AND MOUND, SET 2-1/2 INCH BRASS CAP ON 1" (I.D.) X 30" GALVANIZED IRON PIPE, 18" ABOVE GRADE, MARKED AS SHOWN IN DETAIL BELOW. REINFORCED EXPOSED PIPE WITH STONE MOUND AND SOIL TO CAP. SET 4 REFERENCE MONUMENTS AS DESCRIBED AND DETAILED BELOW. BURIED PITTED STONE IN MOUND ON NORTH SIDE OF THE BRASS CAP. BEARINGS WERE TAKEN WITH HANDHELD COMPASS; DISTANCES WERE MEASURED WITH FIBERGLASS TAPE MEASURE.
