Umatilla NATIONAL FOREST

CORNERS OF THE PUBLIC SURVEY

T. 1 S. R. 36 E. W. _____ Mer. _____

Section _____ Corner common to Sections
25, 36, 30, and 31

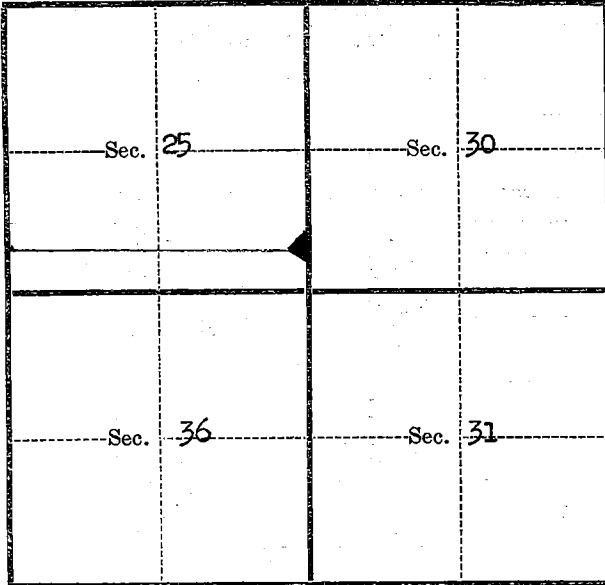
(Make sketch of topography near Corner)

Corner consists of a stump squared (not) in place
 State condition grown over & fallen down

Species YP Snag YP
 Diameter 10" 2 1/2"
 Bearing N59W S36E
 Distance 30' 27'

Metal Location Poster is on a 36E 37 E
tree YP tree
tree 12 inches diameter, on the S
side of tree
from which this Corner bears N 39 E
34' chain distant.
