U. S. DEPARTMENT OF AGRICULTURE
FOREST SERVICE

CORNERS OF THE PUBLIC SURVEY

19, 20, 30, and 29
Corner common to Sections

CORNER RECORD (SEARCH)

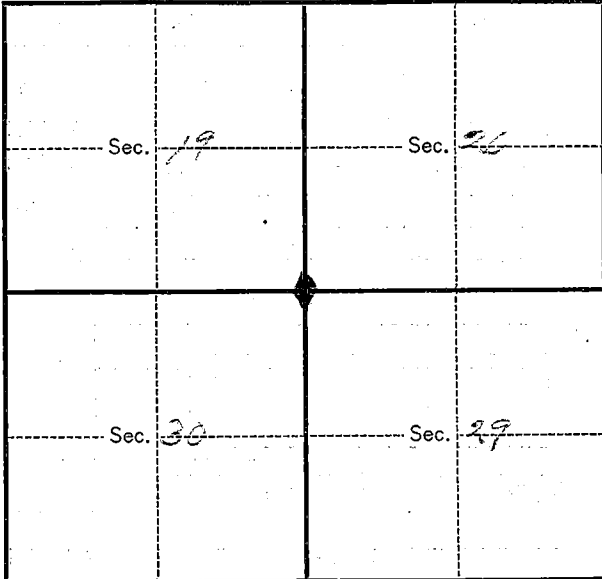
(Make sketch of topography near Corner.)

Metal Location Poster is on a S.F.
tree 18" inches diameter, on the south
side of of road
from which this Corner bears North
35 chains distant.

on the west Pan. ave.
edge
