U. S. DEPARTMENT OF AGRICULTURE
FOREST SERVICE

Umatilla NATIONAL FOREST

CORNERS OF THE PUBLIC SURVEY

CORNER RECORD (SEARCH)
(Ref. FSM 7151.4)

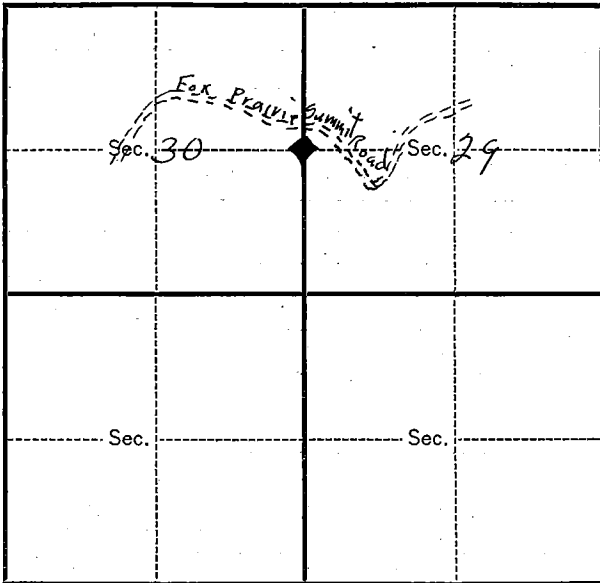
(Make sketch of topography near Corner.)

Metal Location Poster is on a LP
 tree 4 inches diameter, on the NE
 side of the tree
 from which this Corner bears N36E
4 chs chains distant.

Summit
The Fox Prairie Road
runs about 4 chain
north of the corner
on which a crosser's
flag has been placed
Type S.P. slope -
gentle, north.

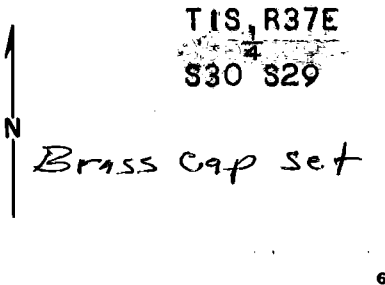
CORNER DIAGRAM

STONE-NO MARKINGS

15" PINE ROTTEN STUMP S38W 17.8'
15" ROTTEN PINE STUMP S57E 11.2'

THESE STUMPS FIT FOR BEARING AND DISTANCE. THERE WAS NO SCRIBING VISIBLE BUT OLD RIBBON AND AXE MARKS ³
~~SHOW THIS TO BE WHERE SCRIBING WAS FOUND IN THE PAST~~

SET 2"x30" IRON PIPE WITH BRASS-OAP MARKED:

14" FIR S67W 33.3' MKD. 1/4 S30 BT

8" FIR N74E 12.0' MKD. 1/4 S29 BT

THE TWO TREES SET HAVE A RED PAINTED STRIPE, 54-3&4 SIGNS, AND A BRASS WASHER STAMPED RLS 346. BT TAGS WERE PLACED ON THE ROTTING STUMPS.
