Amatulla NATIONAL FOREST

CORNERS OF THE PUBLIC SURVEY

CORNER RECORD (SEARCH)
(Ref. FSM 7151.4)

Index File No. Z-1 T. 15 R. 37E M. WILL Tract or Surv. No. Cor. 13
 GPO : 1984 O - 439-095

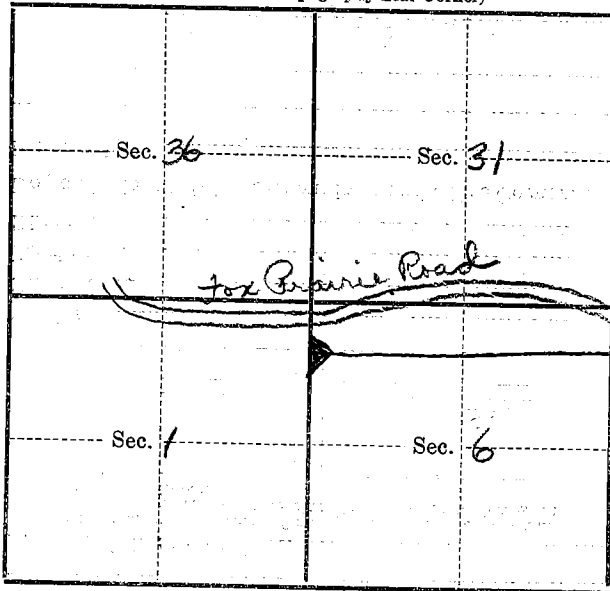
(Make sketch of topography near Corner)

Corner consists of a stake (~~not~~) in place
State condition Very poor

Dimensions above ground 2" X 1 1/2" X 3" inches.

Species _____ Y.P.
Diameter _____ 16"
Bearing _____ N 70 E
Distance _____ 1/4 chm.

Metal Location Poster is on a V.P.
tree 14 inches diameter, on the South
side of Corner
from which this Corner bears N-20W
1/2 chains distant.

Approx. 20 rods south of
section line board which lies
on South side of Fox Prairie
Road 5 ft from road.

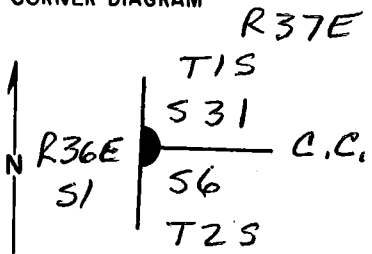
CORNER DIAGRAM

ORIGINAL CORNER TREE IS DOWN & DECAYED.
SCRIBES VISIBLE, "00"

STUMP HOLES IS ALL THAT REMAINS OF
THE TWO ORIGINAL BT'S:
N64°E, 26.4 ft.
S35°E, 5.5 ft.

200' South of Road 31

in the center of the corner tree stump hole & set a 2 1/2" Alum pipe x 30" long w/ 2 1/2" Alum Cap, Cap is protruding 5" & is marked

T 15
 R 51 | 531 C R
 E 56 C 7
 1986 PLS 1636 E

21" Ponderosa Pine N58°E 43.8ft, Scribed "T15 R37E 531 CC BT"
 14" W. LARCH S1°W, 39.5ft, scribed "T25 R37E 56 CC BT"
 Both BT'S have a 3/4" brass washer marked "PLS 1636"
 nailed to the blaze between the B & T. Both BT'S have
 54-3 & 54-4 sign signs nailed to them.
