U. S. DEPARTMENT OF AGRICULTURE
FOREST SERVICE

Umatilla NATIONAL FOREST

CORNERS OF THE PUBLIC SURVEY

T. 2-37 R. 38 E N Mer.

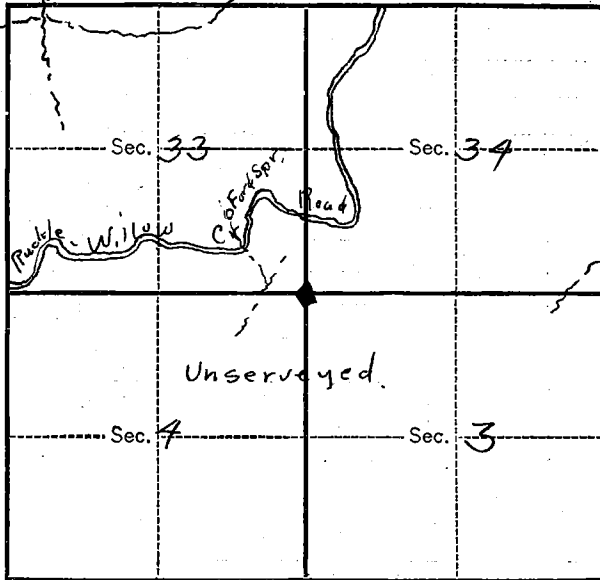
(Make sketch of topography near Corner.)

Metal Location Poster is on a W 7
tree 16 inches diameter, on the NW
side of tree
from which this Corner bears N 22 W
20 links distant.

Corner is found in W 7.
tree on a moderate
southwest slope 19
chains south of road.
A survey tag and
section line sign board
are placed on south side
of road due north of
corner
