OREGON CORNER RESTORATION FORM

Section 11 Township 3N Range 27E
 County Umatilla Date 06-27-02

Corner Designation: 3N27E25

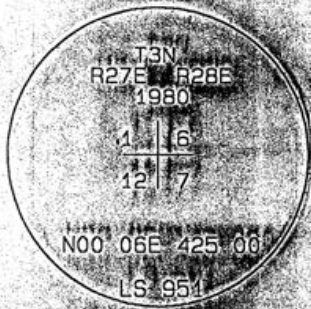
SKETCH

Found both the GLO and Survey 90-49-B brass capped witness corners in good condition. Computed corner location from the witness corner and from adjacent brass capped corners.

Found both the witness corner and the filed survey plat to have transposed numbers based on the record location of other brass capped monuments tied. The distance recorded as 426.00' should have been 452.00'.
