CORNER RECORD (SEARCH)

Tract or Survey No. 5-67 Cor. No. R-15

T 3S R. 31E R.D. Ukiah County Umatilla

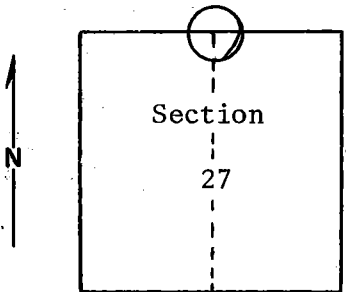
CORNER DIAGRAM

Material: Granite stone. Size: 12" x 10" x ?

Six ~~feet~~ inches above ground. No visible markings. Stone is 2 feet south of east-west fence.

48-inch rotting p.pine stump, 3 feet high, bears N8^{OW}, approximately 60 feet from stone. No scribing visible. (Possible B.T.)

No evidence of B.T. in SE quadrant.
