Index
File No. P-25
T 4S R. 33 1/2 E
Merid. WILLAMETTE

CORNER RECORD (SEARCH)

R.D. LA GRANDE County UNION Tract or Survey No. _____
N.F. WALLOWA-WHITMAN State OREGON Cor. No. E. 1/4 COR. SEC. 24

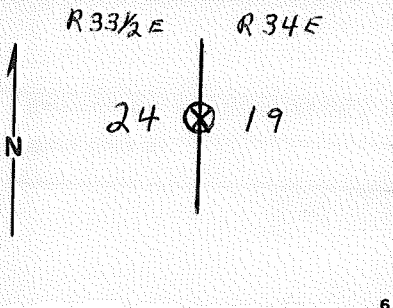
CORNER DIAGRAM

Rock, 8x12x9, is ground level and in poor condition.
4 rocks assumed to be 1/4 cor.

B.T. 20" ponderosa pine, approx. 90' S. 60° W. from cor. Location poster on this one.
Possible B.T. 34" dead ponderosa pine snag, 143' (approx) E. of cor.
I painted the cor. & B.T.'s red. Shields are needed for the BT's.

The corner is in an opening, 25' W. of corner is a very small draw. The cor. is approx. 843' N. of Salsbury Road.
