OREGON CORNER RESTORATION FORM

Section 34 Township 5N Range 28E

S 1/4 Sec. 34
(Standard 1/4 Corner)

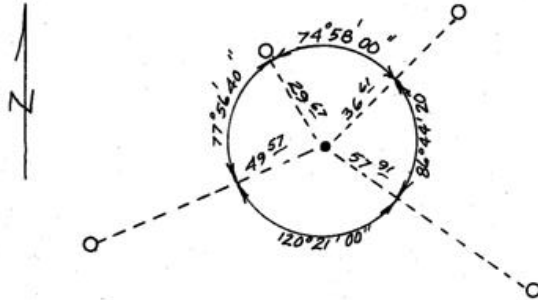
Sketch

Previous Renewals/Surveys, etc. H. J. G. Maxon & Jared Hurd set post in mound of earth with trench & pits in 1860; Driver set RR spike in 1976; Krumbein set Brass cap in 1980; Edwards found P-K with Monument(s) & Accessories Found: (Condition and Source) straddles in Found P-K nail with straddles - no evidence of brass cap. 1993

Set 4 - 5/8" x 30" iron pins with yellow plastic caps marked "UMA CO R D LS 2627", one in each quadrant, with "Please do not disturb" and bearing object tags near each.
