OREGON CORNER RESTORATION FORM

SECTION 15, 22 TOWNSHIP 5 NORTH RANGE 29 EAST
COUNTY : UMATILLA DATE DEC/22

CORNER DESIGNATION
1/4 CORNER

CONDITION REPORT ONLY
 NOT FOUND
 RENEWED
 UNCOVERED
 SURVEYED IN
 REFERENCED

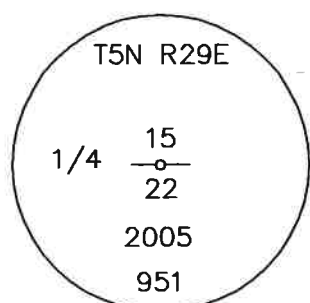
MONUMENT DETAIL

FOUND 2 3/8" BRASS CAP STAMPED AS BELOW.
FOUND 5/8" IRON ROD WITH YELLOW PLASTIC CAP STAMPED LS 951 BEARS N 16°41'26" E, 566.27'.
FOUND 5/8" IRON ROD WITH YELLOW PLASTIC CAP STAMPED LS 951 BEARS N 04°40'42" E, 656.07'.
FOUND 5/8" IRON ROD WITH YELLOW PLASTIC CAP STAMPED LS 951 BEARS N 14°53'34" W, 985.89'.
FOUND 5/8" IRON ROD WITH YELLOW PLASTIC CAP STAMPED LS 951 BEARS N 40°20'21" W, 1224.98'.
