USDA-FOREST SERVICE

File No. A-19

CORNER RECORD (SEARCH)

Corner Diagram T6S R30E

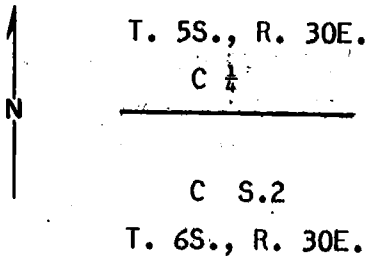
CORNER DIAGRAM

DESCRIBE CORNER MONUMENT FOUND

None
Set brass cap

From the intersection of U. S. Forest Road 419N and 537N, go East along 537N to Gulliford Crossing 1.8 miles, then East 1.6 miles, then walk South 15.2 chns. to corner.

Set 2½" x 30" iron pipe with brass cap.

Pipe is 22" in ground.

Stamped:

PLS 933

A 14" pine bears S. 41°12' E. 55.7 ft.

A 9" fir bears S. 67°54' W. 47.4 ft.

Set steel fence post 4 ft. West of corner w/sign.

Painted red band around BT trees w/sign.
